**Second Five-Year Review Report  
Peterson/Puritan, Inc. Superfund Site  
Towns of Cumberland and Lincoln  
Providence County, Rhode Island  
September 2007**

Prepared by  
Engineering/Planning Division  
New England District  
Concord, MA

Prepared for  
United States Environmental Protection Agency  
Region I-New England  
Boston, Massachusetts

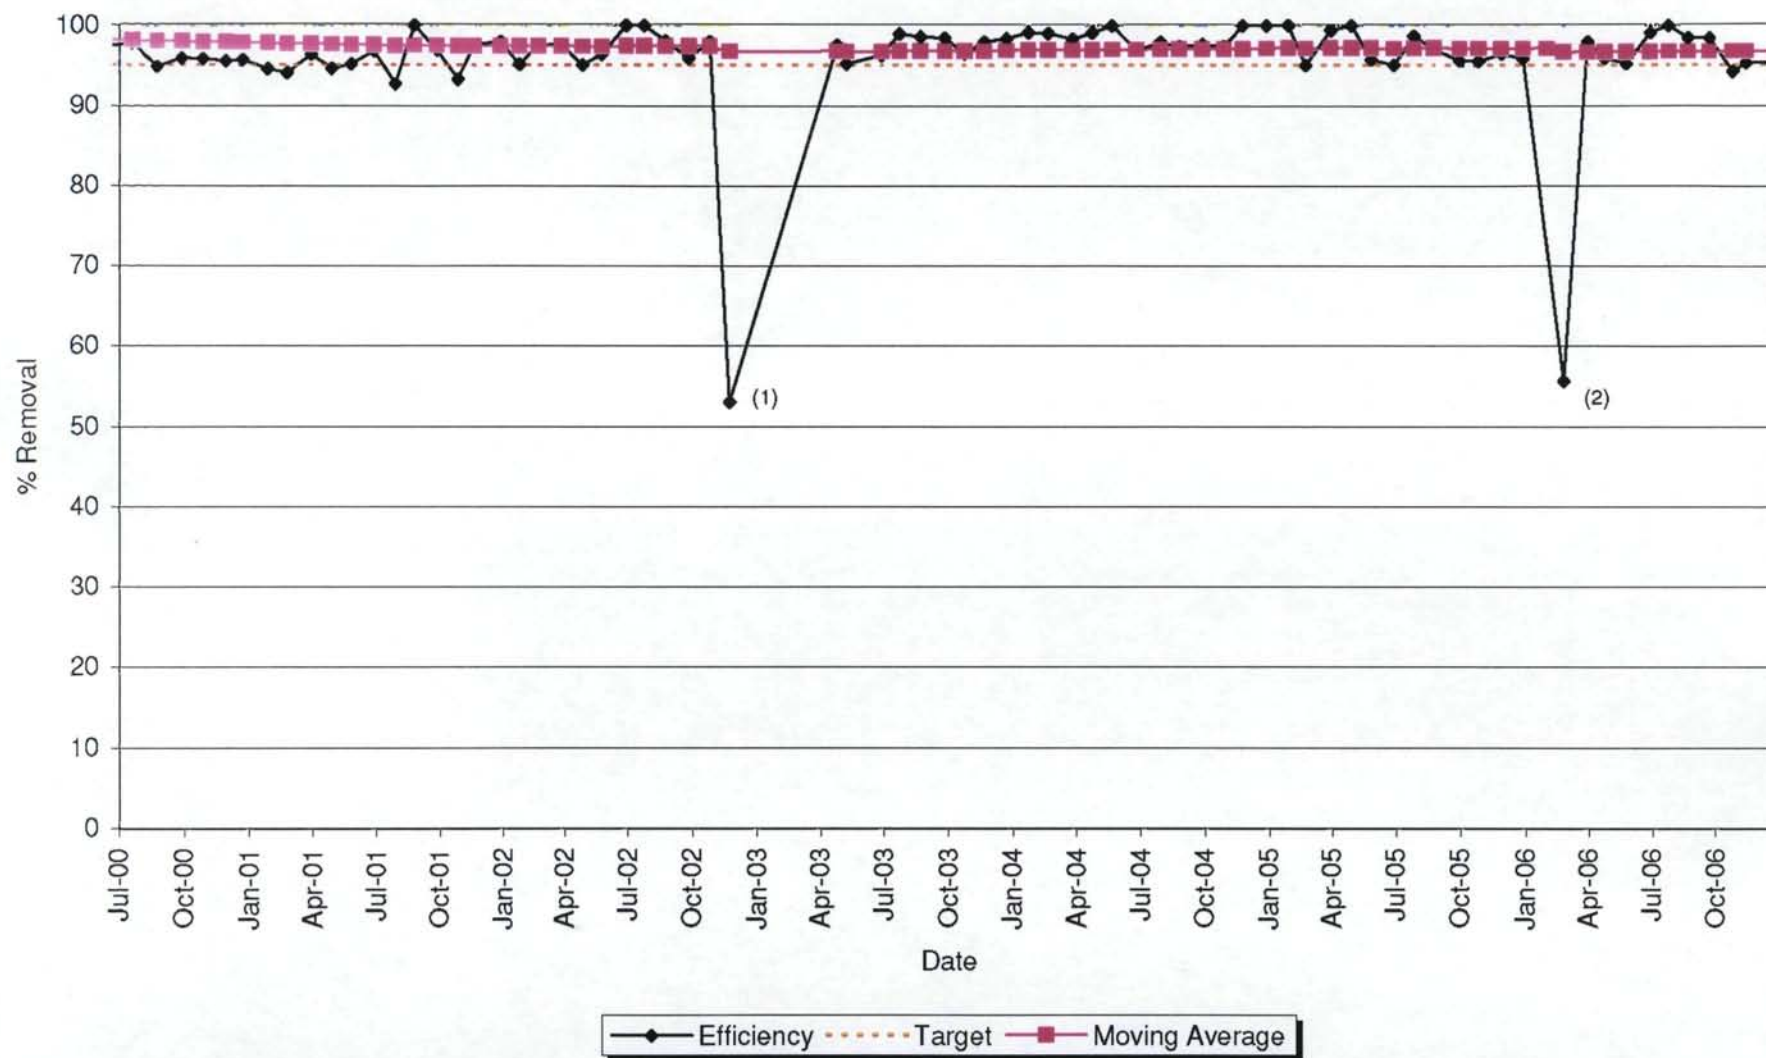
**Figure 8. GAC Removal Efficiency at CCL Remediation Area  
 Peterson/Puritan Superfund Site, OU-1, Cumberland, RI (ENSR, 2007)**

- (1) - SVE down during carbon vessel replacement  
 (2) - Carbon changed after testing result

Composite samples of the CAS influent and effluent vapor streams over an entire adsorb cycle were collected during the five-year review process in accordance with Conditional Test Method 011 (CTM-011). The purpose of the sampling was to verify that the CAS is meeting the required 95% vapor phase VOC concentration reduction and that VC is less than or equal to 10 parts per million by volume (ppmv) in the effluent stream. Analysis results are included in Table 3. As this table shows, the permit requirements of 95 percent VOC removal and less than 10 ppmv VC in the effluent are being achieved by the CAS.
